Manhole Inspection Summary

Manhole # S55A__022MH

Location Address: **3534 e fayette st**

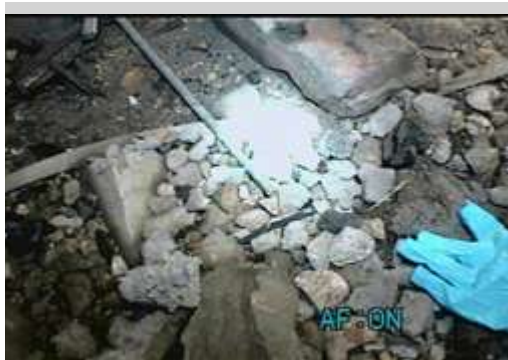
Defect 4

Condition: ☐ Sound ☐ Cracked ☐ Root Intrusion ☐ Deteriorated ☐ Leaks ☒ **Debris**

channel debris

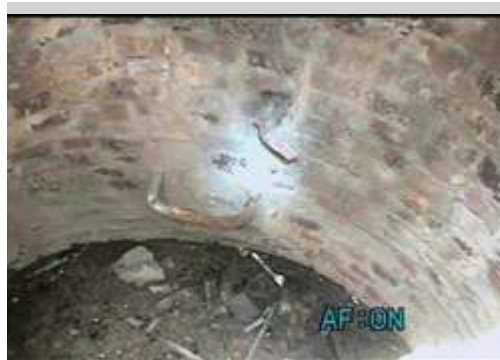
Defect 3

Count: **3** Missing: **1** ☒ **Corroded**

2nd set of steps

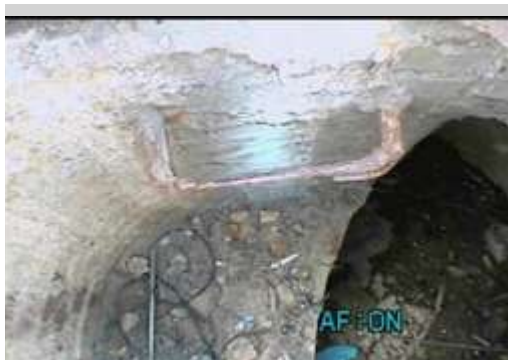
Defect 2

steps & shelf

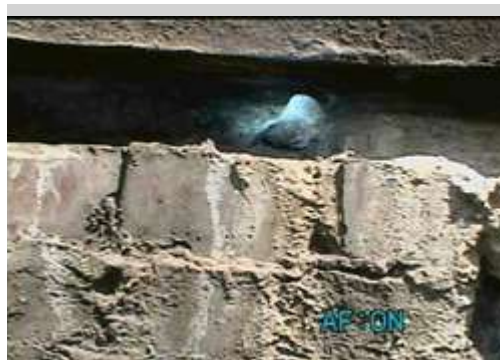
Defect 1

Condition: ☐ Sound ☐ Cracked ☐ Root Intrusion ☒ **Loose Brick** ☒ **Deteriorated**

chimney loose bricks,deteriorated,
frame adj

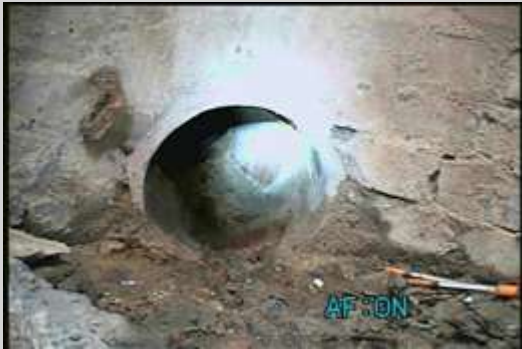
12 O'Clock Outflow

8 in. Circular Gravity Sewer
Pipe Out @ 12 O'Clock
